City of Arlington ADA Ramp Evaluation Form

(A) Background Information			
(A1.1) Ramp ID Number:	67	(A1.7) Road Name (1) (N/S):	WEST AVE
(A1.2) GPS Coordinations:	N/A	(A1.8) Road Name (2) (E/W):	E HALLER
(A1.3) Evaluator Name:	IAN DAVIS	(A1.9) Quadrant or Side of Road:	E/W
(A1.4) Date Evaluated:	6/10/2015	(A1.10) Number of Approaches:	STOP ON E/W
(A1.5) Ramp Location:	L	(A1.11) Traffic Controll Type:	4
(A1.6) Ramp Type:	Perpendicular	(A1.12) Marked Crosswalked (Y/N)?	Y

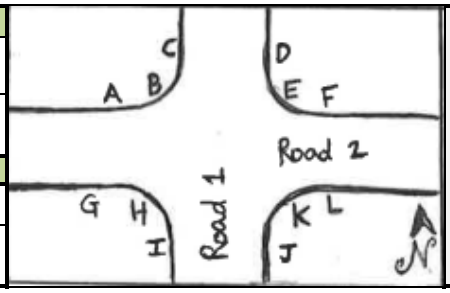
(B) Perpendicular Ramps		(D) Parallel Ramps		(E) Combination Ramps			
(B1) Landing		**(D1) Landing**		**(E1) Landing**			
(B1.1) Run Slope (%):	7.2%	(D1.1) Run Slope (%):		(E1.1) Run Slope (%):			
(B1.2) Cross Slope (%):	5.4%	(D1.2) Cross Slope (%):		(E1.2) Cross Slope (%):			
(B1.3) Length (ft):	13+	(D2.3) Length (ft):		(E1.3) Length (ft):			
(B1.4) Width (ft):	4+	(D1.4) Width (ft):		(E1.4) Width (ft):			
(B2) Ramp		**(D2) Ramps**	**Left** / **Right**	**(E2) Ramps**	**Left**	**Center**	**Right**
(B2.1) Cross Slope (%):	6.2%	(D2.1) Cross Slope (%):		(E2.1) Cross Slope (%):			
(B2.2) Width (ft):	3.2	(D2.2) Width (ft):		(E2.2) Width (ft):			
(B2.3) Run Slope (%):	13.7%	(D2.3) Run Slope (%):		(E2.3) Run Slope (%):			
(B2.4) Length (ft):	5.4	(D2.4) Length (ft):		(E2.4) Length (ft):

(B3) Flares and Returned Curbs		
(B3.1) P.C.P. Crosses the Ramp (Y/N)?	N	
(B3.2) Flares Present (Y/N)?	Y	
(B3.3) Flare Slope (%):	**Left**	**Right**
	14.8%	4.0%
(B3.4) Returned Curbs Protected (Y/N)?	N

(G) General Curb Ramp Elements					
(G1) Surfaces and Grade Breaks		**(G2) Detectable Warning Surfaces**		**(G3) Gutter Counter Slopes**	
(G1.1) Are all grade breaks flush (Y/N)?	Y	(G2.1) DWS Present (Y/N)?	Y	(G3.1) Gutter Counter Slope (%):	13.9%
(G1.2) Obstructions/ Utility Covers (Y/N)?	N	(G2.2) Adequate Visual Contrast (Y/N)?	N	(G3.2) Gutter Flow Line Slope (%):	5.0%
(G1.3) Vertical Discontinuities (Y/N)?	N	(G2.3) Extends Full Width of Landing (Y/N)?	Y	**(G4) Clear Space & Alignment**	
(G1.4) Horizontal Gaps (in.)?	N/A	(G2.4) Both Ends Located at the Back of the Curb (Y/N)?	N	(G4.1) Adequate clear Space Beyond Face of Curb (Y/N):	Y
(G1.5) Grade Breaks Perp. to Slopes (Y/N)?	Y	(G2.5) Distance of Farthest Corner from Back of the Curb (in.)?	4	(G4.2) Curb Ramp Falls Within Crosswalk (Y/N)?	Y
(G1.6) Planar Surfaces (Y/N)?	Y	(G2.6) Length of DWS in the Direction of Travel (in.)?	65	(G4.3) Curb Ramp Located Outside of Curb Radius (Y/N):	N
