City of Arlington ADA Ramp Evaluation Form

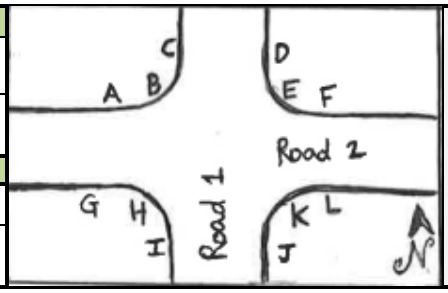
(B) Perpendicular Ramps		(D) Parallel Ramps		(E) Combination Ramps	
(B1) Landing		**(D1) Landing**		**(E1) Landing**	
(B1.1) Run Slope (%):	6.50%	(D1.1) Run Slope (%):		(E1.1) Run Slope (%):	
(B1.2) Cross Slope (%):	10.30%	(D1.2) Cross Slope (%):		(E1.2) Cross Slope (%):	
(B1.3) Length (ft):	2	(D2.3) Length (ft):		(E1.3) Length (ft):	
(B1.4) Width (ft):	6	(D1.4) Width (ft):		(E1.4) Width (ft):

(B2) Ramp		(D2) Ramps	Left	Right	(E2) Ramps	Left	Center	Right
(B2.1) Cross Slope (%):	8.80%	(D2.1) Cross Slope (%):			(E2.1) Cross Slope (%):			
(B2.2) Width (ft):	3	(D2.2) Width (ft):			(E2.2) Width (ft):			
(B2.3) Run Slope (%):	8.10%	(D2.3) Run Slope (%):			(E2.3) Run Slope (%):			
(B2.4) Length (ft):	5	(D2.4) Length (ft):			(E2.4) Length (ft):

(B3) Flares and Returned Curbs		
(B3.1) P.C.P. Crosses the Ramp (Y/N)?	Y	
(B3.2) Flares Present (Y/N)?	Y	
(B3.3) Flare Slope (%):	**Left**	**Right**
	17.2%	0.3%
(B3.4) Returned Curbs Protected (Y/N)?	N
