City of Arlington ADA Ramp Evaluation Form

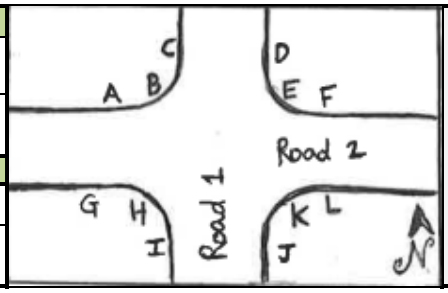
(B3) Flares and Returned Curbs		
(B3.1) P.C.P. Crosses the Ramp (Y/N)?	N	
(B3.2) Flares Present (Y/N)?	Y	
(B3.3) Flare Slope (%):	**Left**	**Right**
	2.1%	9.1%
(B3.4) Returned Curbs Protected (Y/N)?	N
