Drainage Report for:

Arlington Flight Services – Site Grading/Paving

August 10, 2012

Prepared by:
Cascade Surveying & Engineering., Inc.

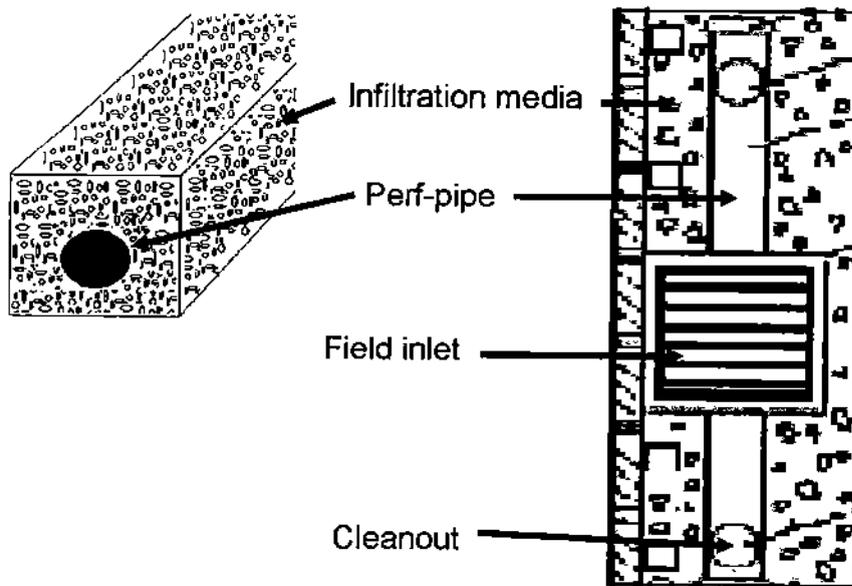
Infiltration Trench

A stormwater infiltration trench is a closed basin built by excavating below existing ground. Infiltration trenches temporarily store stormwater runoff during rain events. Infiltration trenches do not discharge to a downstream conveyance system or nearby surface water. Instead, infiltration trenches rely on the ability of the site's soils to infiltrate the stormwater into the ground.

Facility objects that are typically associated with an infiltration trench include:

- access road or easement
- fence, gate, and water quality sign
- bioswale
- sediment trap
- field inlet

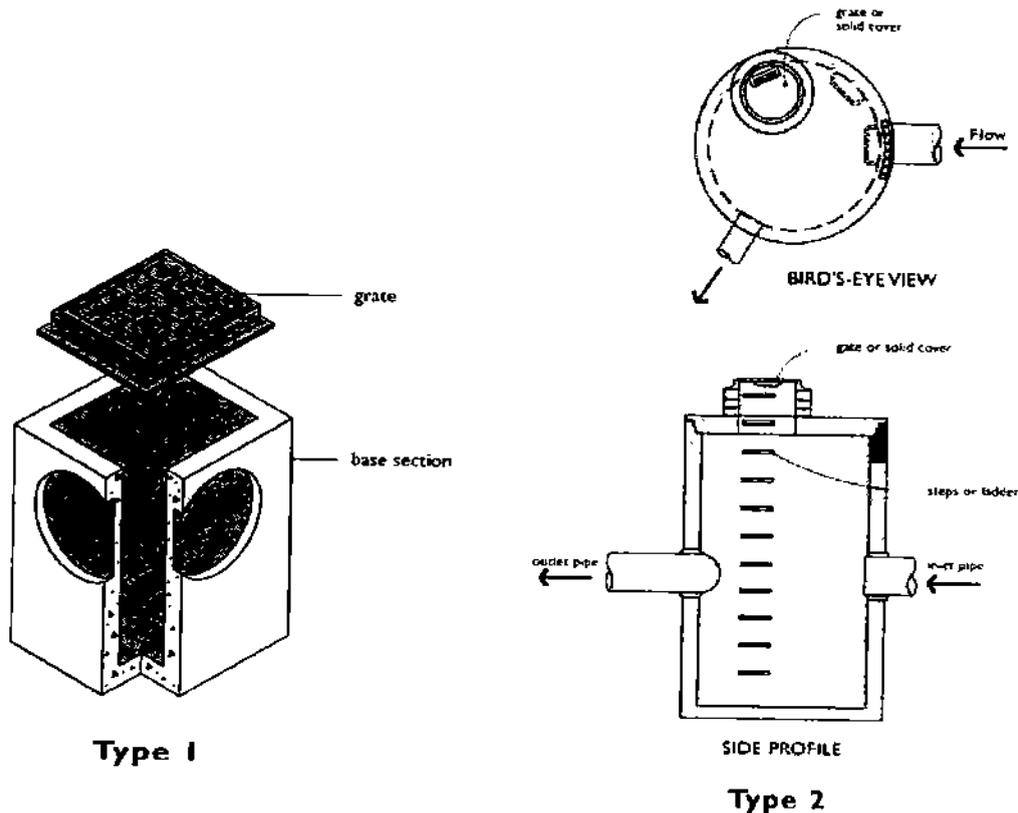
Catch Basin

The most common tool for cleaning catch basins is a truck with a tank and vacuum hose (vector truck) to remove sediment and debris from the sump. A catch basin may be an enclosed space where harmful chemicals and vapors can accumulate. Therefore, if the inspection and maintenance requires entering a catch basin, it should be conducted by an individual trained and certified to work in hazardous confined spaces.

Catch basins are typically associated with all stormwater facilities.
