Re: Hertz Equipment Rental, Arlington

**Drainage Calculations
Dwayne Lane's North Sound Car and Truck
16424 Smokey Point Boulevard N.E.
Arlington, Washington**

Prepared by:
Bryant O. Mercil, P.E.

March 18, 2004
Revised May 20, 2004

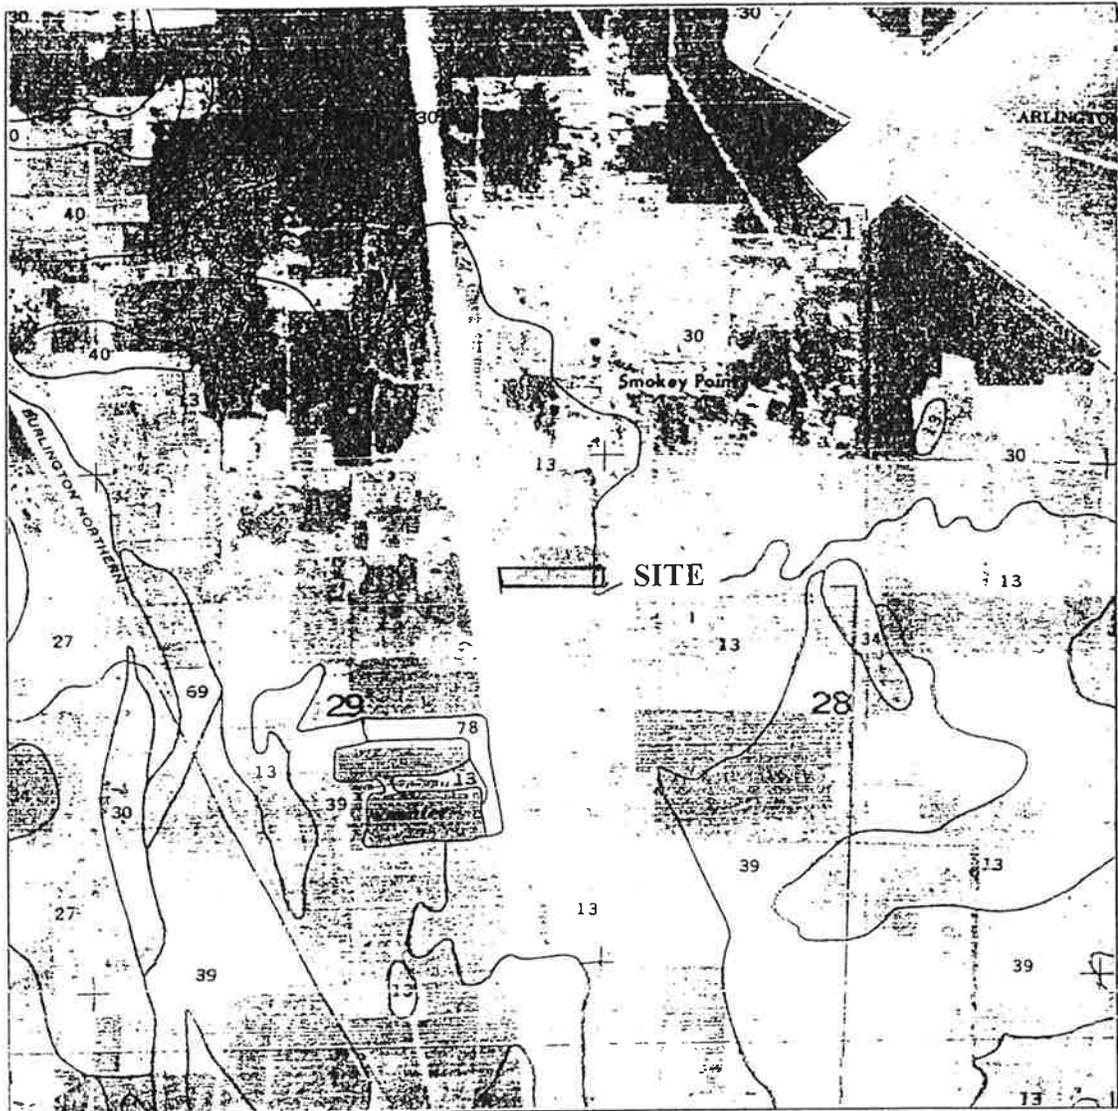
SOILS MAP
SCALE: 1" = 2,000'

Reference: Soil Survey of Snohomish County
Sheet Number 19

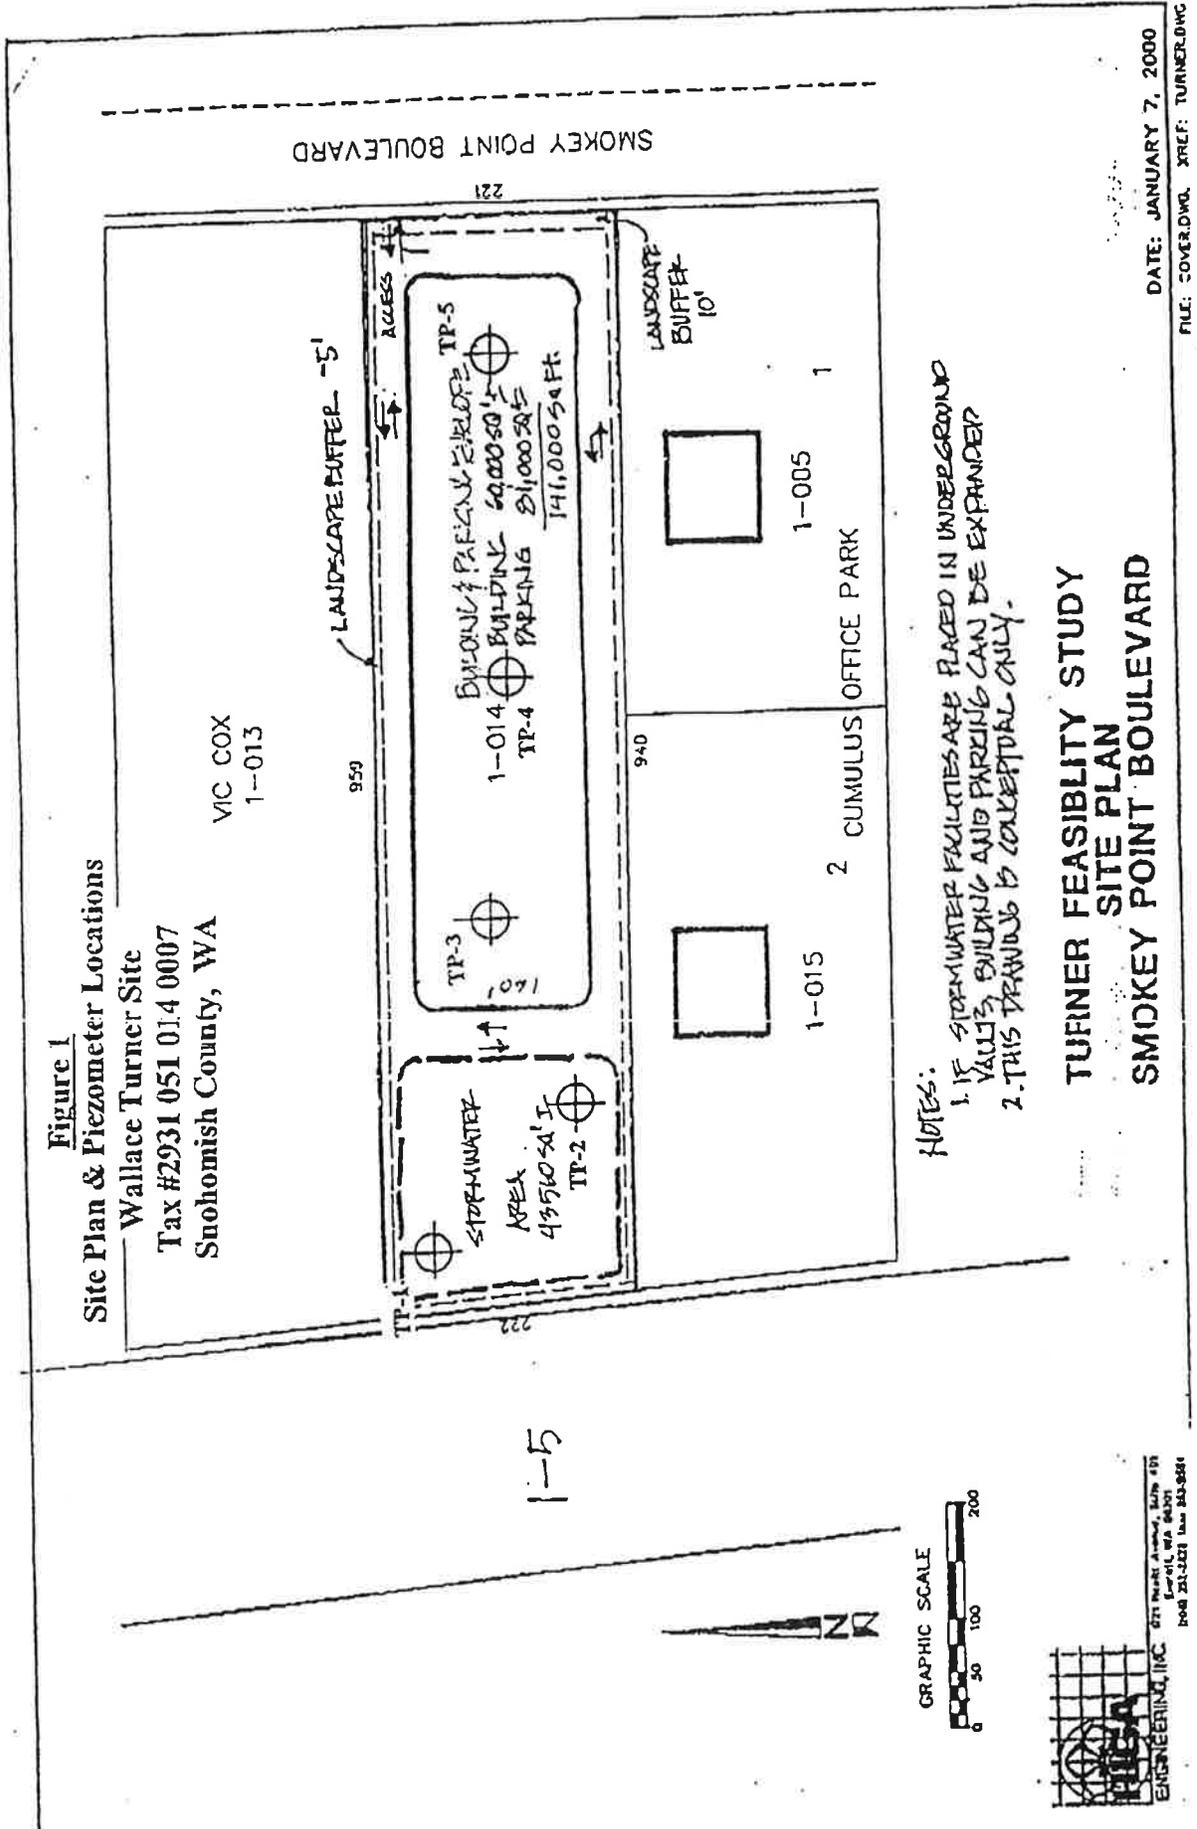
Wallace Turner Site
Tax #2931 051 014 0007
Snohomish County, WA

- IF STORMWATER FACILITIES ARE PLACED IN UNDERGROUND VAULTS, BUILDING AND PARKING CAN BE EXPANDED.
- THIS DRAWING IS CONCEPTUAL ONLY.

Western Geotechnical Consultants, Inc. is pleased to present the results of our subsurface site investigation conducted at the above referenced property. On January 24, 2000 a geotechnical engineer and a geologist from our firm traveled to the site to oversee the excavation of 5 test pits across the property. The project plan involves site development for an approximately 60,000 square foot building and associated parking and an approximately one-acre stormwater detention facility. It is possible that stormwater facilities will be placed in underground vaults in which case building and parking facilities could be expanded. The property encompasses approximately 4.8 acres and is located south of 169th Place NE between Smokey Point Boulevard and Interstate 5. Figure 1 is a site plan showing the general property layout together with the approximate test pit locations.

Subsurface conditions at the site were evaluated by excavating a total of 5 test pits on January 24, 2000 with a CAT 416 rubber tire backhoe using a 3-foot-wide bucket. The approximate locations of the test pits are shown on the attached Site Plan, Figure 1. The test pits were roughly located in the field by pacing and by using a cloth tape to measure from the property boundaries on the site. Piezometers were installed in all of the test pits and the test pits were loosely backfilled upon completion of the explorations.

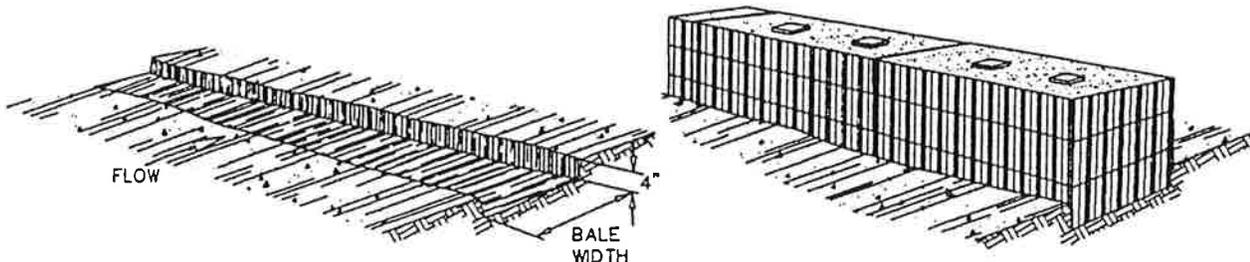
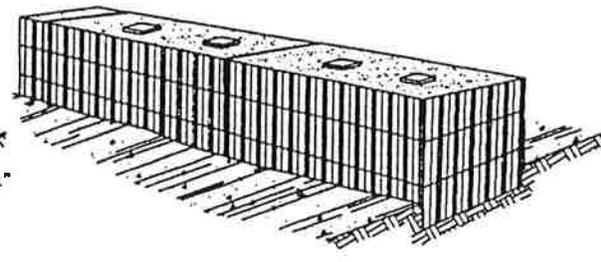
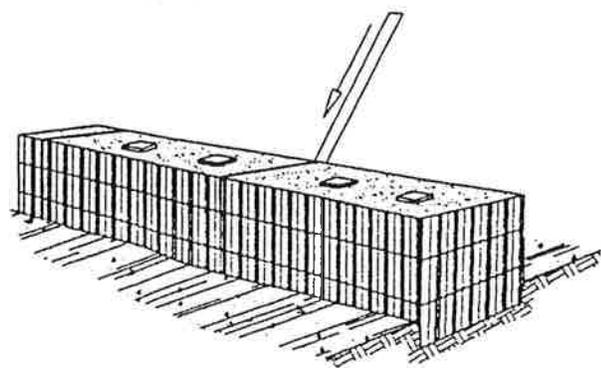
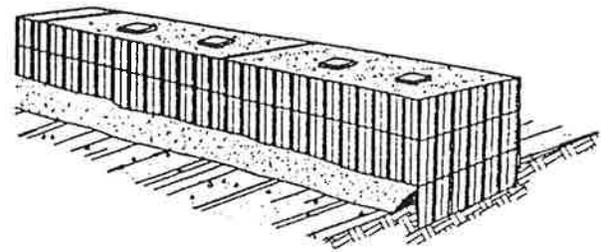
CONSTRUCTION OF A STRAW BALE BARRIER
NOT DRAWN TO SCALE

1. EXCAVATE THE TRENCH.

2. PLACE AND STAKE STRAW BALES.

3. WEDGE LOOSE STRAW BETWEEN BALES.

4. BACKFILL AND COMPACT THE EXCAVATED SOIL.

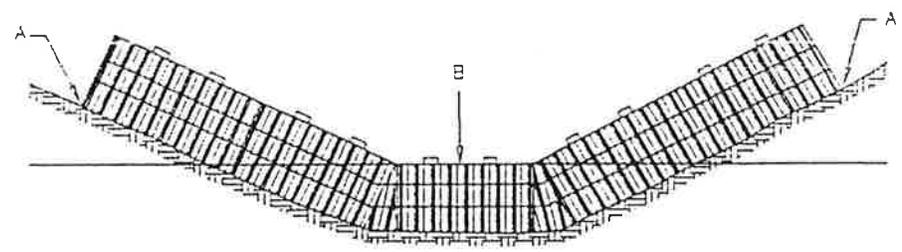
PROPER PLACEMENT OF STRAW BALE BARRIER IN DRAINAGE WAY
NOT DRAWN TO SCALE

POINTS A SHOULD BE HIGHER THAN POINT B

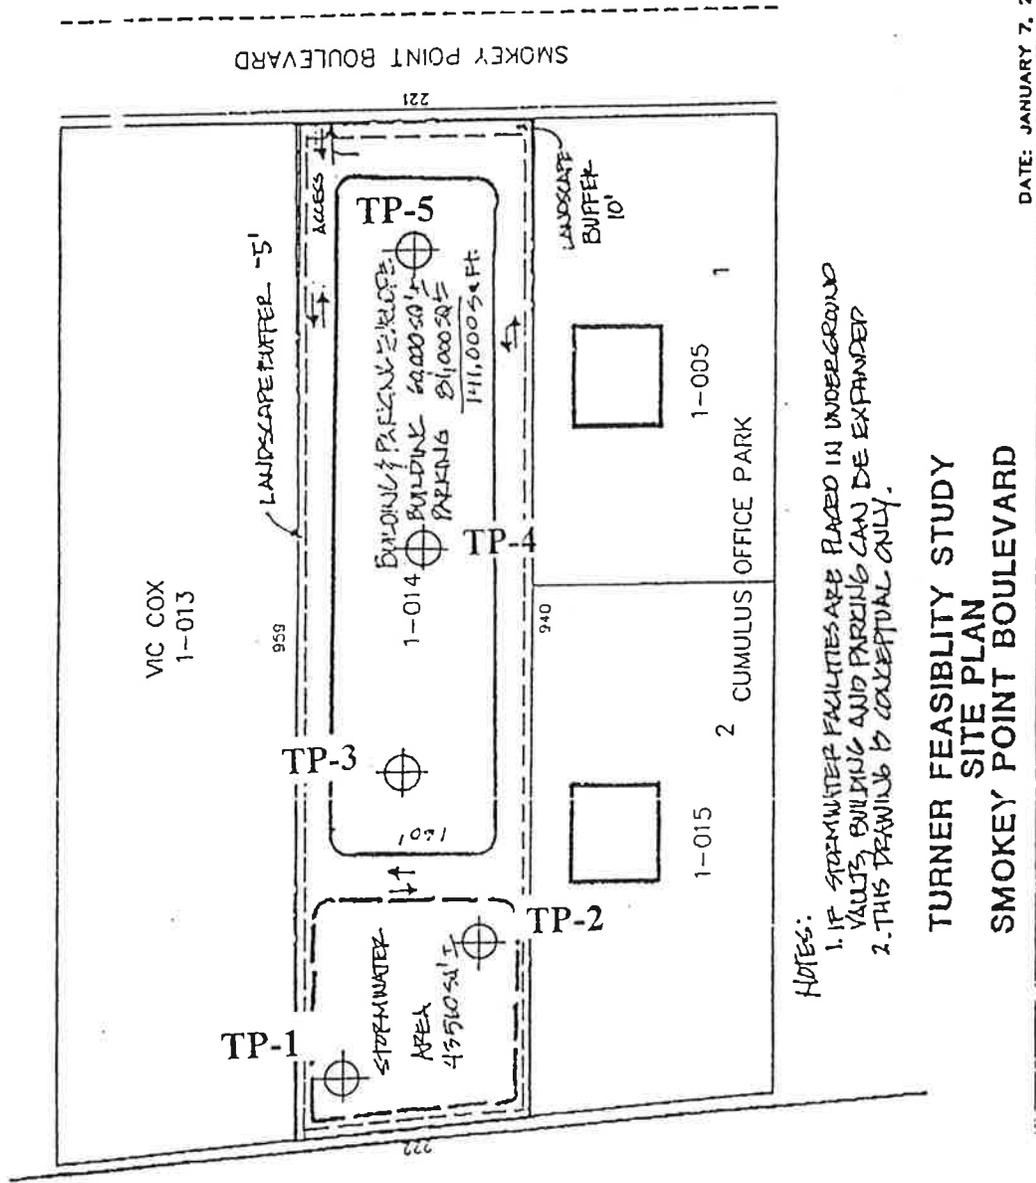
Figure 1

Site Plan & Test Pit Locations
Wallace Turner Site
 Tax #2931 051 014 0007
 Snohomish County, WA

NOTES:
 1. IF STORMWATER FACILITIES ARE PLACED IN UNDERGROUND VAULTS, BUILDING AND PARKING CAN BE EXPANDED.
 2. THIS DRAWING IS CONCEPTUAL ONLY.
