Drainage Report For:

2-Lot Short Plat

Gary Peterson & Dave Molstad – File Number: Z-04-005-SP

March 23, 2004

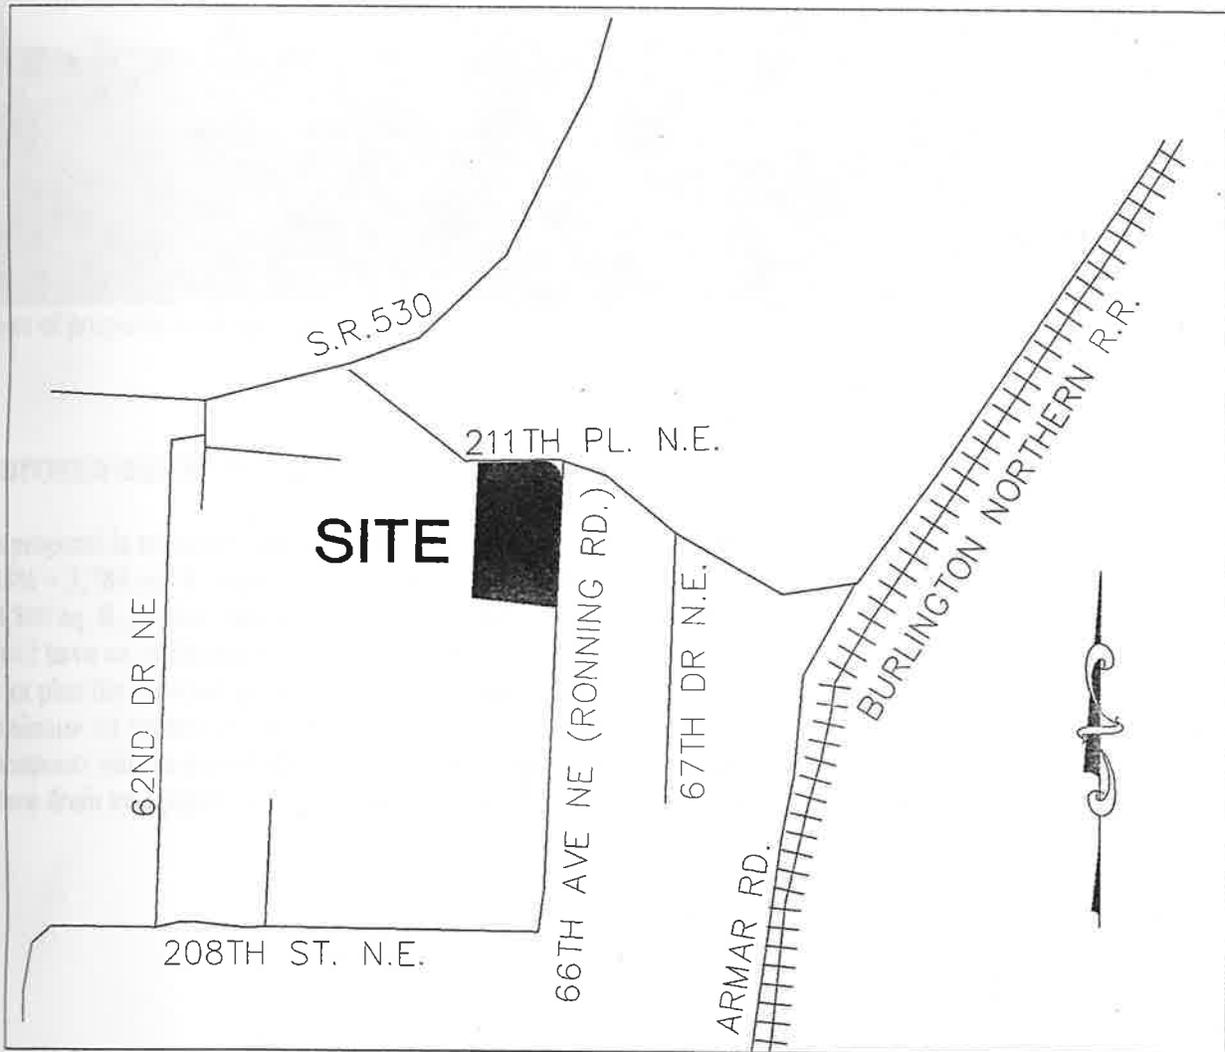
Figure 1: Vicinity Map

The site of proposed development is located in the NE ¼ of the SE ¼ of Section 10, Township 31 N, Range 5E, W.M. The properties tax number is 310510-004-019-00. The property is 0.50 acres in size (See Vicinity Map below).

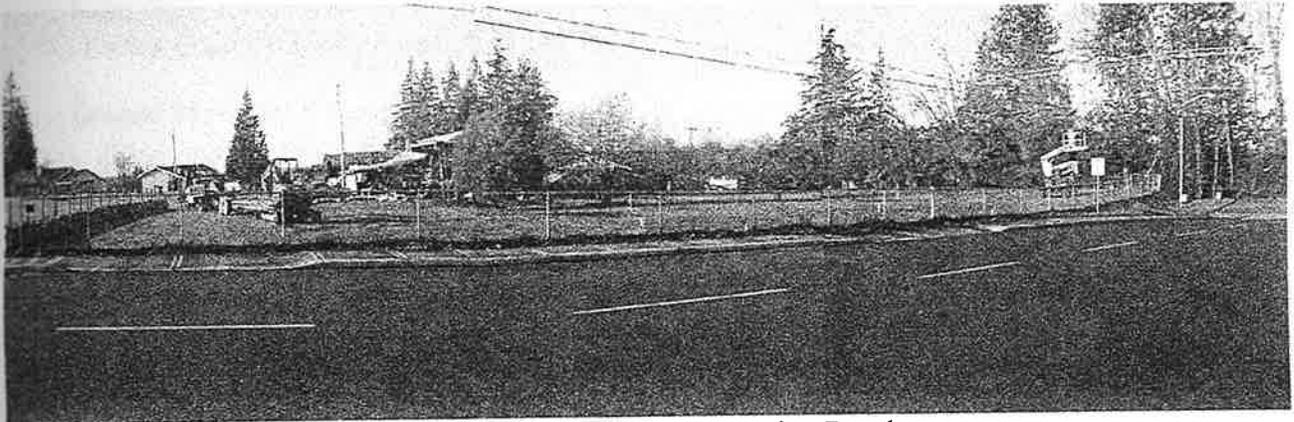
Views of property looking West to Northwest from across Ronning Road.

The property consists of lawn, with 4 fruit trees and two ornamental trees. The property is bounded on the North and East by public right of way (211th Pl NE and Ronning Road). The property is flat (0.5% to 1% slopes) with very deep gravels and sands (Everett gravelly sandy loam). Rain water infiltrates directly into the ground with no significant lateral movement. Currently there are no impervious areas on the site.

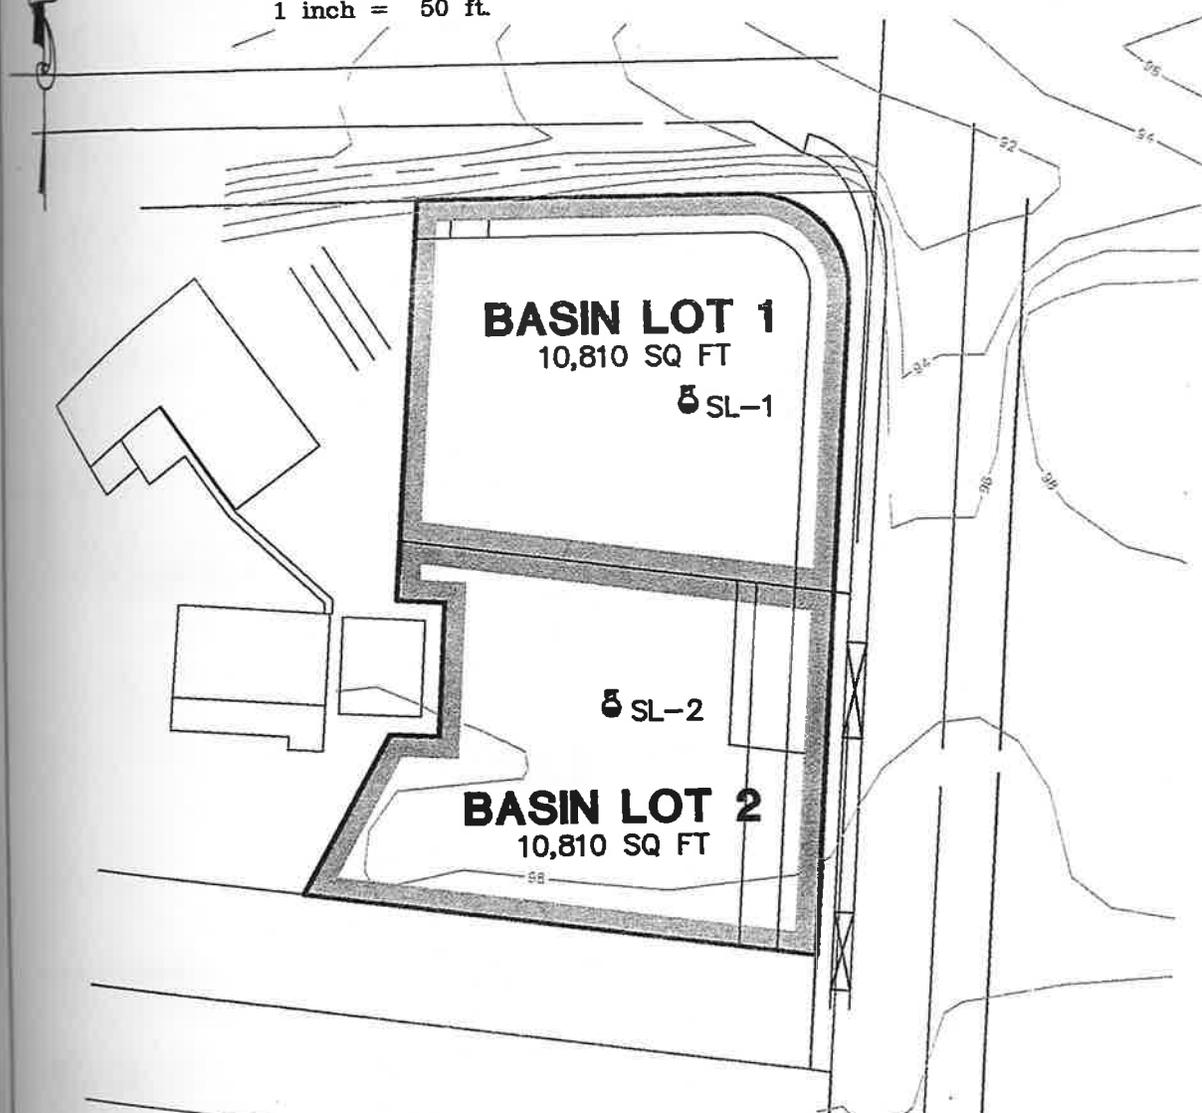
DRAINAGE BASIN & SOIL LOG MAP

LOT 1	SL-1	0-12" 12-42" 42-96+"	DARK BROWN SANDY LOAM TAN GRAVELY MEDIUM SAND GRAY GRAVELY MEDIUM SAND
LOT 2	SL-2	0-8" 8-24" 24-96+"	DARK BROWN SANDY LOAM TAN GRAVELY MEDIUM SAND GRAY GRAVELY MEDIUM SAND

NOTE:
THE SOIL LOG HOLES WERE DUG ON DECEMBER 17, 2003. NO SIGNS OF MOTTLING WAS OBSERVED IN EITHER HOLE. IT IS THE ENGINEERS OPINION THAT THE REQUIRED SEPERATION BETWEEN THE BOTTOM OF THE TRENCH AND THE HIGH GROUNDWATER CAN BE MET, EVEN DURING PERIODS OF HIGH GROUND WATER.

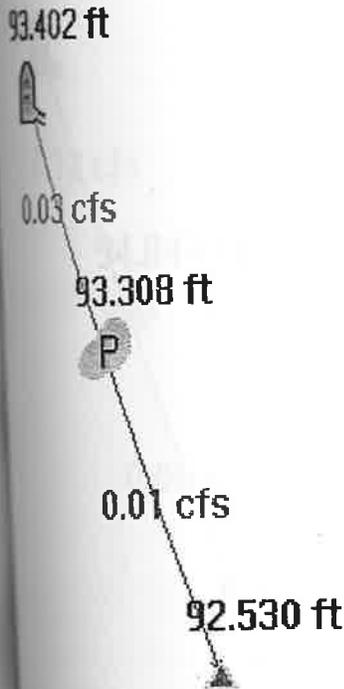
6-MONTH CALCULATIONS

ROUTEHYD [] THRU [DEV] USING TYPE1A AND [6 mo] NOTZERO RELATIVE

Reach	Area ac	Flow cfs	Full Q cfs	% Full ratio	nDepth ft	Size ---	nVel ft/s	fVel ft/s	CBasin / Hyd -----
Routing thru RLPool Node CB; 6 mo event									
Line	Match Q: 0.0000 cfs Peak Out Q: 0.0281 cfs - Peak Stg: 93.29 ft - Active Vol: 0.57 cf								
REACH	0.2482	0.0281	0.8620	0.03	0.0620	6" Diam	2.0057	4.3900	SITE
Routing thru RLPool Node TRENCH; 6 mo event									
Line	Match Q: 0.0000 cfs Peak Out Q: 0.0077 cfs - Peak Stg: 93.31 ft - Active Vol: 55.63 cf								
REACH	0.2482	0.0077	1560.32	0.00	0.0078	48" Diam	4.2014	124.1667

STORM EVENT	INFILTRATION TRENCH STORAGE	INFILTRATION TRENCH STAGE
	cf	ft
DEV. 6-mo.	56	93.31
DEV. 100-yr	243	94.84

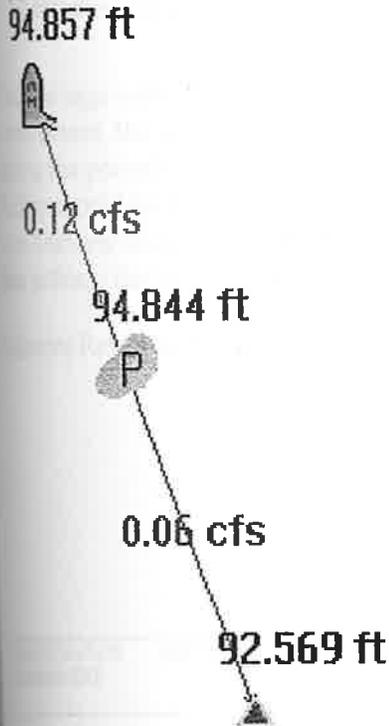
100-YR CALCULATIONS

ROUTEHYD [] THRU [DEV] USING TYPE1A AND [100 yr] NOTZERO RELATIVE

Reach	Area ac	Flow cfs	Full Q cfs	% Full ratio	nDepth ft	Size —	nVel ft/s	fVel ft/s	CBasin / Hyd —
Routing thru RLPool Node CB; 100 yr event									
100 yr	Match Q: 0.0000 cfs Peak Out Q: 0.1220 cfs - Peak Stg: 93.28 ft - Active Vol: 0.50 cf								
CBTR	0.2482	0.1220	0.8620	0.14	0.1271	6" Diam	3.1048	4.3900	SITE
Routing thru RLPool Node TRENCH; 100 yr event									
100 yr	Match Q: 0.0000 cfs Peak Out Q: 0.0608 cfs - Peak Stg: 94.84 ft - Active Vol: 242.79 cf								
TRENCH	0.2482	0.0608	1560.32	0.00	0.0215	48" Diam	7.2565	124.1667	
From Node	To Node	Rch Loss ft	App Head ft	Bend Loss ft	Junct Loss ft	HW Elev ft	Max El/ Rim El ft		
TRENCH	GROUND	90.5938	-na-	-na-	-na-	92.5693	95.5000		
3	TRENCH	94.8569				94.8440	98.0000
